# Mechanical Decoking of Furnaces the Right Way

Arjo van Toor, Global Business Director at Quest Integrity

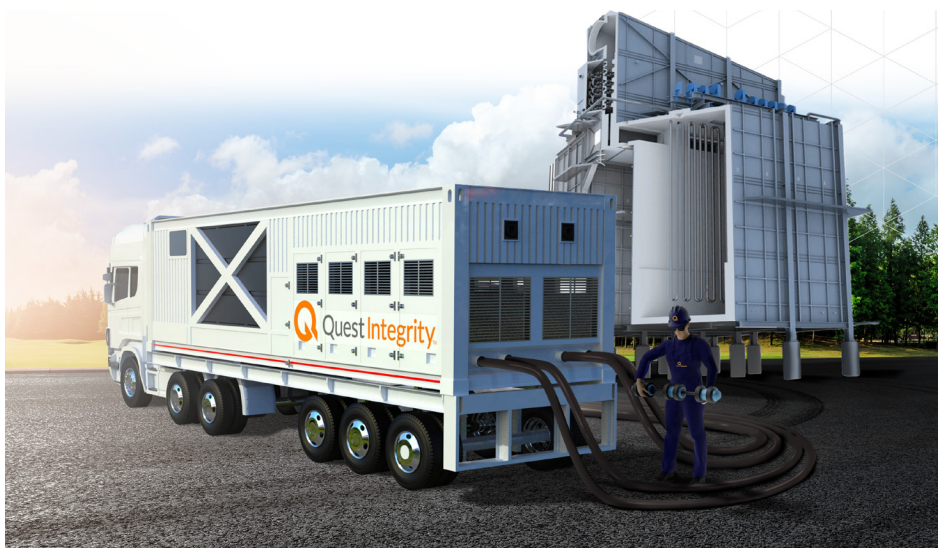
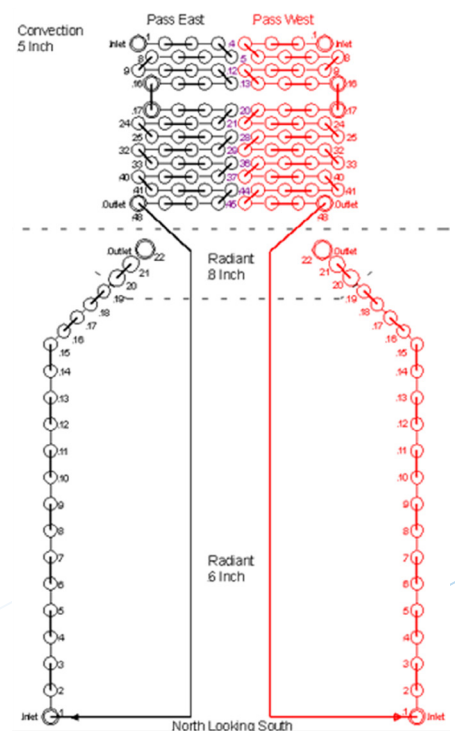
Figure 1. 4-Pass Vacuum Heater

Quest Integrity received an urgent call from a European refinery for an immediate mobilization to perform an Advanced Decoking and Cleanliness Verification (ADCV™) on a 4-pass vacuum furnace. The furnace tripped in less than 24 hours, and tube wall temperatures quickly exceeded the design specifications due to excessive coke formation. The asset-owner had no other option but to take the furnace offline for an unexpected cleaning. It goes without saying that this unplanned outage was going to be very costly due to the loss of production. As such, the asset-owner needed to have the furnace up and running as soon as possible to minimize lost production time.

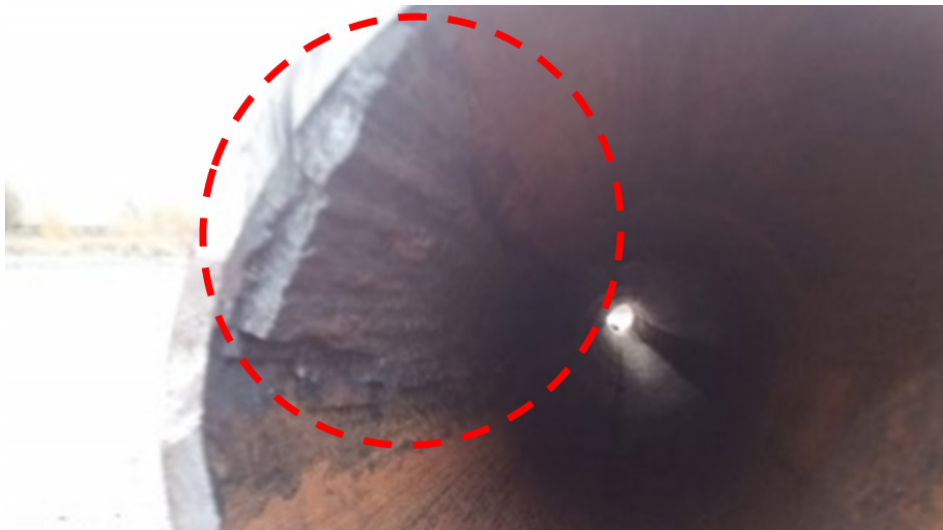
*Figure 2. Internal Fouling*

Over a 14-hour period, Quest Integrity performed an advanced mechanical cleaning of the furnace coils along with a cleanliness verification. An area of internal fouling “coke” had proved to be especially difficult to remove during cleaning operations, and the decision was made to cut out the tube (see coke at 9 o’clock position in Figure 2.) Plant personnel were primarily concerned with understanding why the fouling in this specific area couldn’t be removed during cleaning, which would have eliminated additional downtime and costs. Did the ADCV™ service underdeliver on its promise?

Taking a deeper look at the tube and the coke formation, it became clear that the coke was comprised of two different layers. After the previous conventional mechanical cleaning, the furnace went back online and quickly coked up at the same location over and over again producing the second layer of coke as seen in the tube image.

The leftover coke from insufficient cleaning practices acted as an accelerate for the rapid formation of new coke. Since coke acts as an insulator, elevated temperatures occurred in the previously fouled area. This in turn caused new and more rapidly developing formations to occur on top of the existing layer of coke, making the older layer harder over time.

The older layer of coke became so hard over time that even a metal studded decoking pig could not remove it. To further complicate matters, prolonged overheating from the internal fouling deformed the tube, making it difficult for the cleaning pig to conform to the shape of the tube to properly clean it.

As cleaning operations neared completion, it was noted that an area of localized coke still remained in one of the tubes as shown in Figure 2. Quest Integrity executed numerous cleaning pig runs followed by a final cleanliness verification tool run, and despite best efforts, the existing coke layer remained essentially unchanged.

At this stage, Quest Integrity notified the furnace owner-operator of the situation to discuss next steps. Additional cleaning with an oversized studded decoking pig was not considered, since this would potentially damage the clean tubes. Continuing to clean with the same size decoking pig could eventually remove a small portion of the old coke layer but would have taken considerably longer. Additional cleaning time was not available since the furnace needed to be back online as quickly as possible. It's worth noting that despite the additional cleaning runs at the localized area of fouling, the total project time to carry out the ADCV™ service was 20% less than the previous conventional mechanical cleaning service.

If it was finally agreed that Quest Integrity would provide a map showing the exact location of the fouling (see Figure 5) enabling refinery personnel to cut out and replace the affected tube segment. This plan ensured the furnace could be placed back online without having to address any future consequences such as tube overheating and ruptures from leftover fouling.

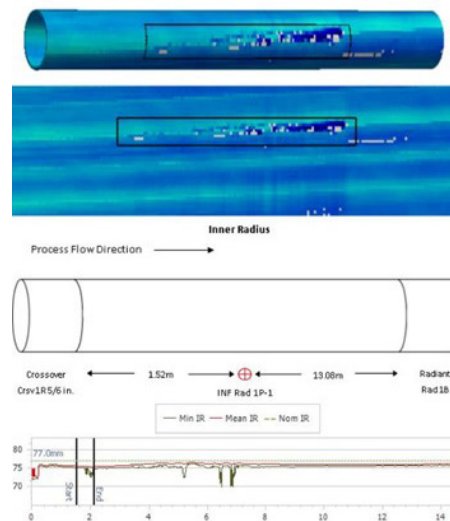
Figure 5. Map of Fouling

Category	VALUE
Internal / External	Internal
* Location	1.52m
Axial Length	0.60m
Circumferential Width	0.10m
Fouling Thickness	3.4mm
Avg. Fouling Thickness	0.6mm

Name	VALUE
Material	A335-P5
Nominal Outside Diameter	168.3mm
Nominal Inside Diameter	154.1mm
Nominal Wall Thickness	7.1mm
