# Cleaning and Inspection of Steam Cracking Furnace Convection Coils Now Possible

## Overview

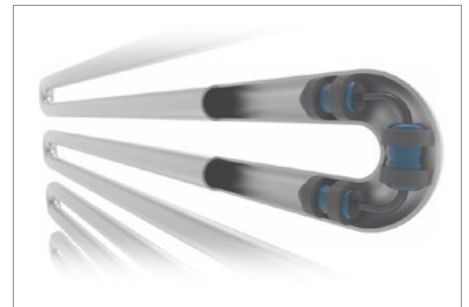
Figure 1. FTIS Smart Pig

Advanced Cleaning uses state-of-the-art pumping trucks and mechanical cleaning pigs to effectively remove internal fouling from tube walls, restoring proper heat transfer and thermal efficiencies. FTIS is a high-resolution ultrasonic in-line inspection technology that detects and measures coil damage such as internal

and external corrosion, erosion, pitting and fretting as well as deformations such as bulging, swelling, denting and ovality. This technique provides owner-operators with a complete and quantitative mapping of a coil's wall thickness and geometry.

To mitigate possible future tube failures and obtain much needed integrity data, an Olefins plant located in Europe contacted Quest Integrity to perform an FTIS™ (Furnace Tube Inspection System) smart pigging inspection (see Figure 1) on a Feed Preheater bundle consisting of 10 coils. The bundle had never been cleaned before and internal fouling was suspected based on findings from a Feed Preheater Bundle in a sister furnace. Tubes from that furnace contained visible discoloration from overheating, which was most likely caused by a buildup of scale on the inside of the tube walls. Given the possible integrity concern and restriction in product flow from the buildup, Quest Integrity was requested to clean the coils in addition to pumping the FTIS tool through the coils using its Advanced Mechanical Cleaning and Pumping Technology.
