Cleaning, Inspection and Assessment of Steam Reformer Convection Coils Now Possible

To mitigate possible future tube failures and obtain much needed integrity data, a Methanol plant located in the Middle East contacted Quest Integrity to perform an FTIS™ (Furnace Tube Inspection System) smart pigging inspection (see Figure 1) and fitness-for-service screening assessment on 100 PNG Preheater coils. The coils had never been cleaned before and light internal fouling was suspected given the number of years in operation. As such, Quest Integrity was requested to clean the coils in addition to pumping the FTIS tool through the coils using its Advanced Mechanical Cleaning and Pumping Technology.

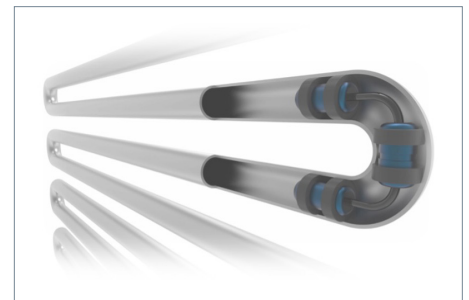
Figure 1. FTIS Smart Pig

Advanced Mechanical Cleaning uses state-of-the-art pumping trucks and mechanical cleaning pigs to effectively remove internal fouling from tube walls, restoring proper heat transfer and thermal efficiencies. FTIS is a high-resolution

ultrasonic in-line inspection technology that detects and measures damage such as internal and external corrosion, erosion, pitting and fretting as well as deformations such as bulging, swelling, denting and ovality in numerous coil configurations. This technique provides owner-operators with a complete and quantitative mapping of a coil's wall thickness and geometry. The inspection data from the FTIS service is then used along with heater design and operating parameters to conduct a LifeQuest fitness-for-service screening assessment following the API 579-1 Standard. This service provides owner-operators with the confidence that a furnace can be returned to service and safely operated until the next planned shutdown.

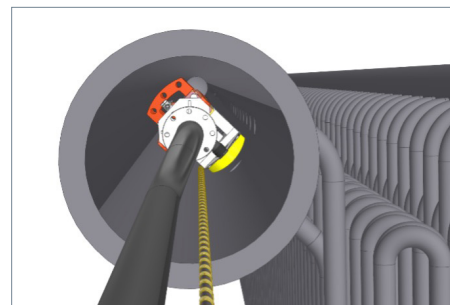
Figure 2. HDS Inside a Common Header

As with many steam reformers, common headers were attached to the inlet and outlet of each coil. This added to the complexity of the project, since the cleaning pigs and FTIS tool would need to travel through the header first for entry into the coils. For successful navigation through the heater, Quest Integrity's Header Delivery System (HDS) was installed inside the inlet and outlet common headers of each coil. The HDS effectively connected the coils via hoses to the water pumps installed on Quest Integrity's cleaning truck (see Figures 2 and 3). This created a closed loop system, allowing water to enter the coils to provide a couplant for the ultrasonic inspection while also propelling cleaning pigs and the FTIS tool through the coil via the cleaning truck pumps.

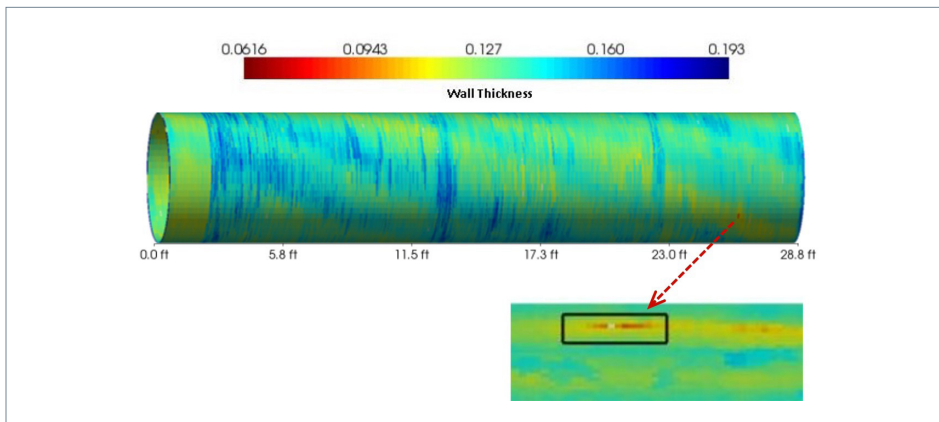
Figure 4. Wall Thickness Plot Showing Localized Wall Loss

The FTIS inspection revealed moderate internal and external localized wall loss upwards of 40 percent in numerous pipes (see Figure 4). General internal wall loss upwards to 26 percent was also present in the 180-degree return bends. The result of the engineering screening assessment showed that the coils were fit for service for the next four-year operating period. A remaining life assessment was also performed on each coil as part of the screening assessment, showing an estimated remaining life of 15 years with a recommendation to re-inspect in four years to monitor corrosion rates and detect any other localized damage that may affect coil integrity.
